7 Westbury Road, Southampton, SO15 4JS

Date of Inspection
3rd February 2020

Inspection Carried Out By
Mark Ninnim

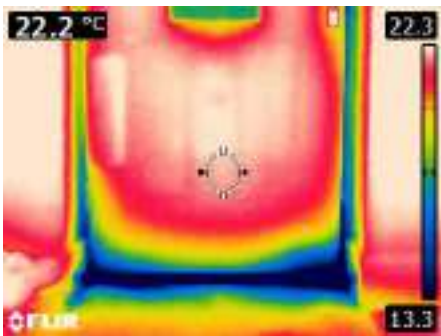
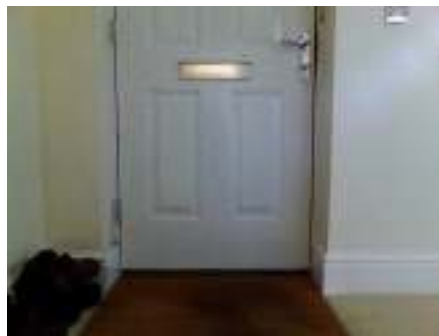
The FD is showing a significant issue with cold air ingress along the foot of the door.

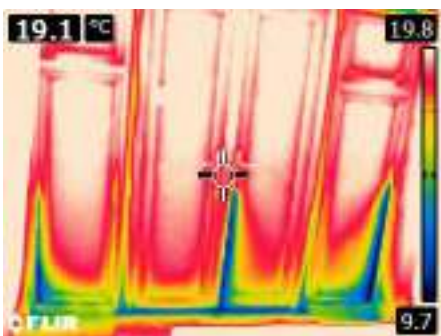
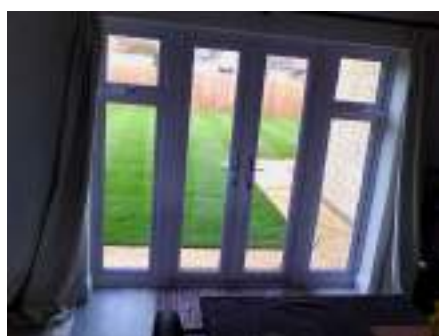
The FD is showing a significant issue with cold air ingress along the foot of the door.

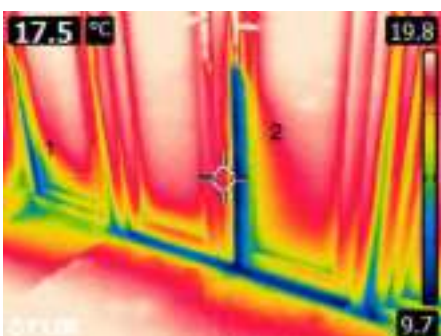
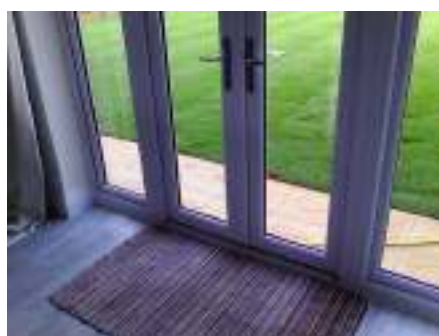
The FD is showing a significant issue with cold air ingress along the foot of the door.

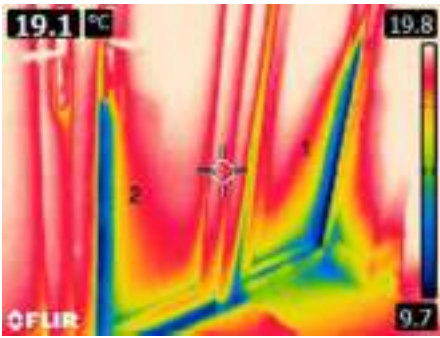
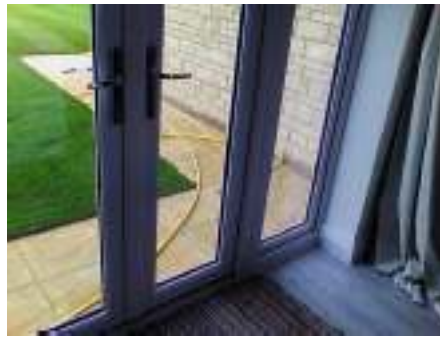
The FD is showing a significant issue with cold air ingress along the foot of the door.

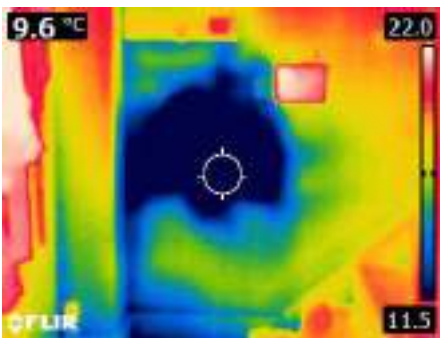
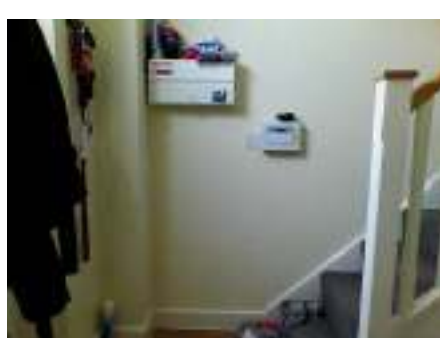
The FD is showing a significant issue with cold air ingress along the foot of the door.

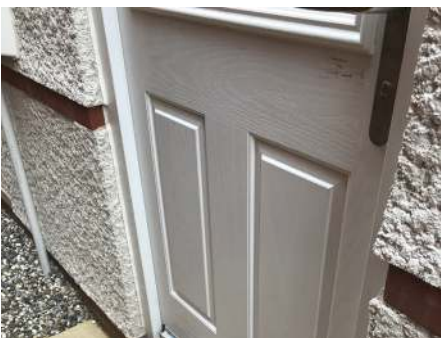
The FD is showing a significant issue with cold air ingress along the foot of the door.
