7 Westbury Road, Southampton, SO15 4JS

Date of Inspection
3rd February 2020

Inspection Carried Out By
Mark Ninnim

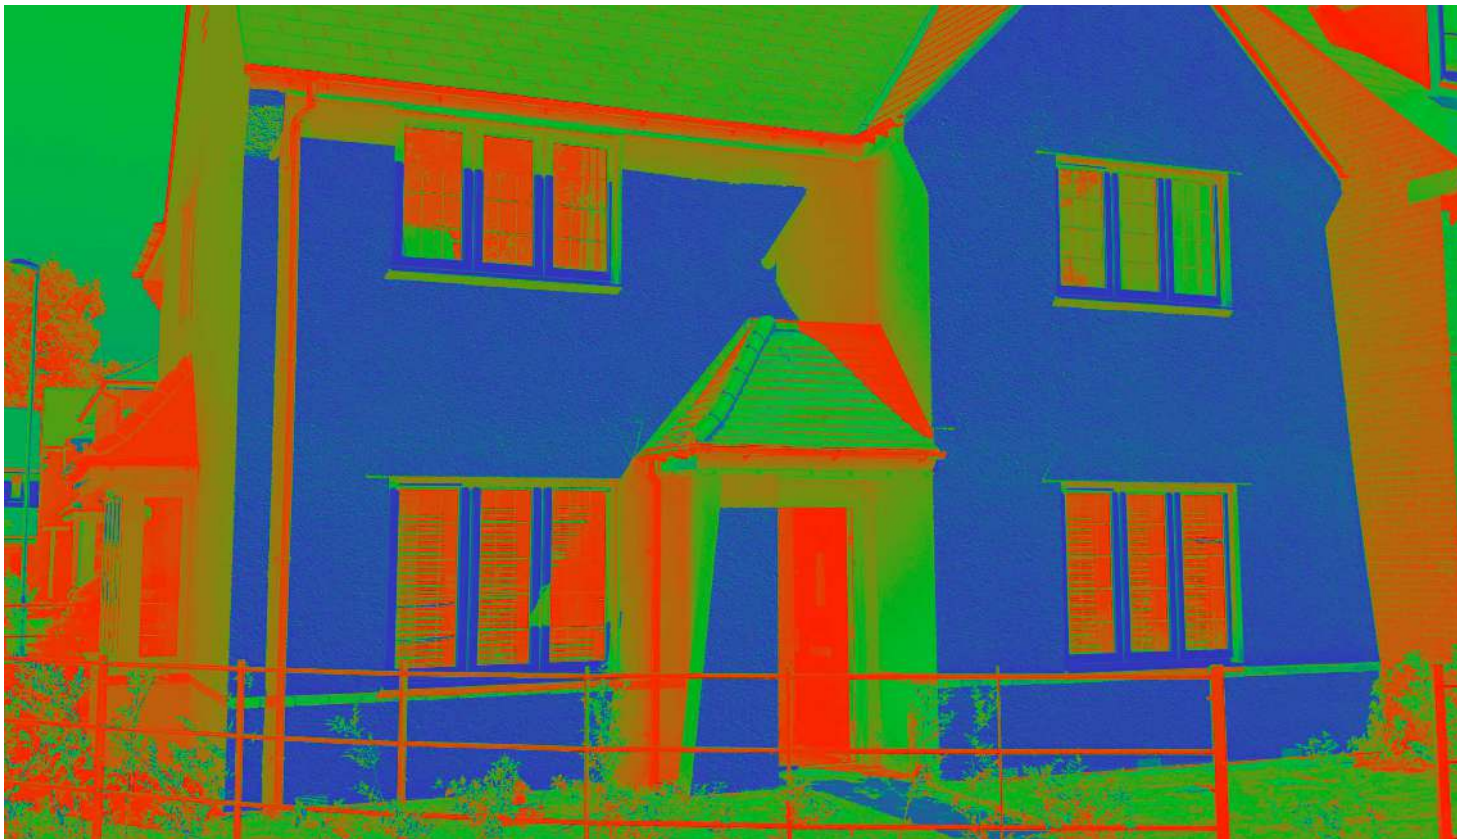
The FD is showing a significant issue with cold air ingress along the foot of the door. The ingress is prevalent to between the door and threshold. This is likely in relation to an inadequate connection and defect to the seal along the threshold. The issue is also worsened to the bottom corners - when inspected this can be seen to be in relation to a gap around the cill/threshold to the skirting which is unfinished.
